REPORT OF MARINE SURVEY

**Pre-purchase Condition and Value
of the vessel**

"Ciao"

2012 40' Azimut 40S

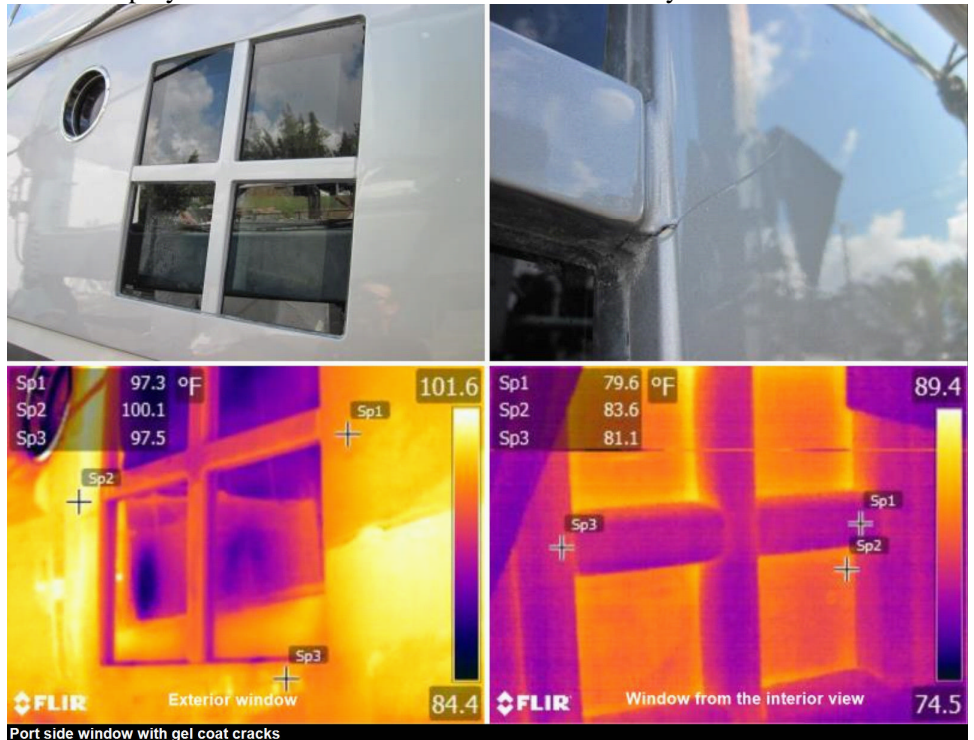
Hull cosmetics were in good condition with mostly minor nicks and scratches sighted. Some gel coat cracking was sighted around the port side large window. Thermal imaging confirmed the cracks were only in the gel coat only. No anomalies sighted that were consistent with trapped water or fiberglass laminate damage.

Findings:	Recommendations:
Some gel coat cracking was sighted around the port side large window. Thermal imaging confirmed the cracks were only in the gel coat only. No anomalies sighted	Have a qualified marine technician repair or renew the areas of gel coat cracks around the port window to prevent water from seeping in to the underlying

that were consistent with trapped water or fiberglass laminate damage (cosmetic only). Some areas of marine caulking was worn away around the drain scupper pockets on the port and starboard sides of the aft quarters of the vessel. fiberglass. If desired, have a qualified marine technician repair / replace the areas of worn caulking around the scupper pockets on the aft quarters of the hull.

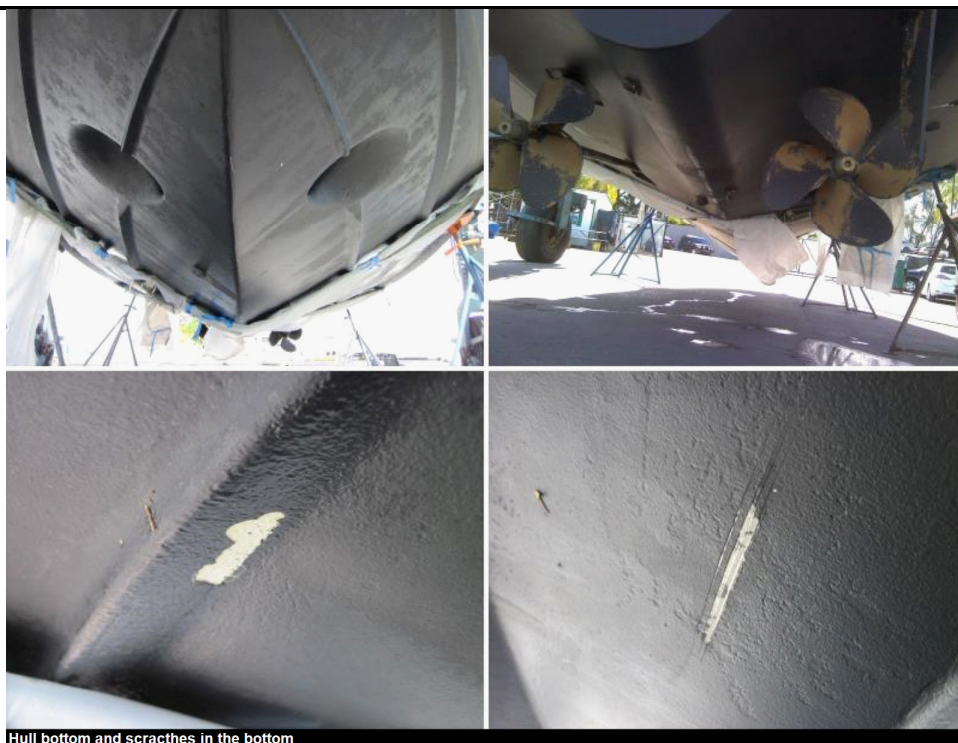
Hull bottom and scratches in the bottom

Anti-fouling bottom paint was sighted on the hull bottom. The anti-fouling paint was in average condition and was scratched down to the bare gel coat in a few areas on the hull bottom.

The anti-fouling paint was in average condition and was scratched down to the bare gel coat in a few areas on the hull bottom. A forward bronze sea strainer for the anchor raw water wash down pump was sighted to be missing one bronze finger in the thru hull fitting on the starboard forward hull bottom near the stem.

Have a qualified marine technician repaint the vessel bottom with proper anti-fouling paint if the vessel is going to be in the water for a long period of time. Have a qualified marine technician further inspect the anchor wash down raw water intake strainer. Repair or replace to prevent sea growth and debris from clogging the thru hull.

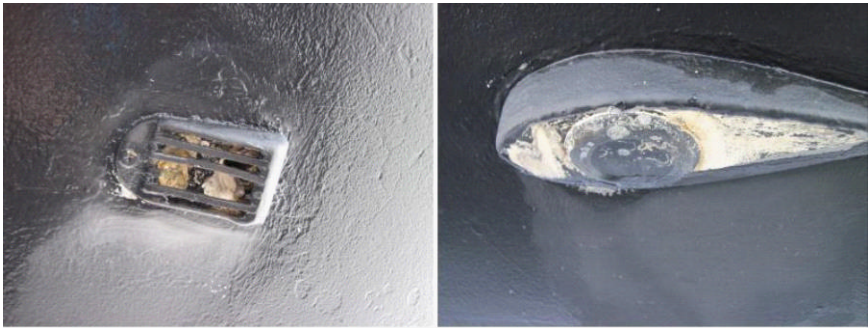
Broken intake fitting & depth sounder

All bronze raw water intake strainers were well secured to the hull bottom. Clear of debris and sea growth. A forward bronze sea strainer for the anchor raw water wash down pump was sighted to be missing one bronze finger in the thru hull fitting on the starboard forward hull bottom near the stem.

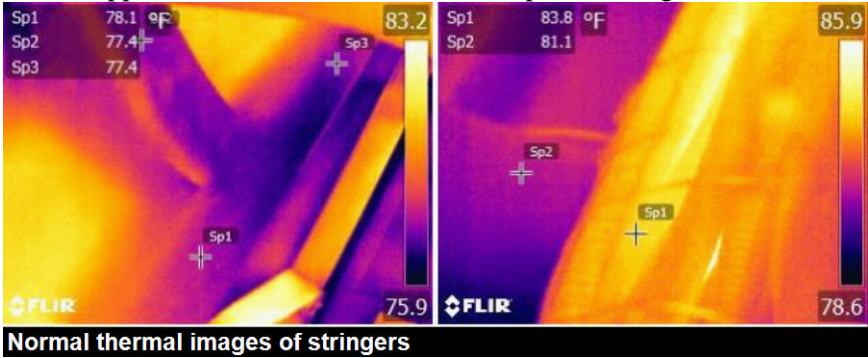
Thermal images of the stingers and transverse frames were normal. No anomalies were discovered that were consistent with damage or delamination.

Findings:	Recommendations:
Some of the grip tape on the tops of the stringers and transverse frames were peeling off in the engine compartment when inspected.	If desired, have a qualified marine technician repair or replace the peeling grip tape in the engine compartment.

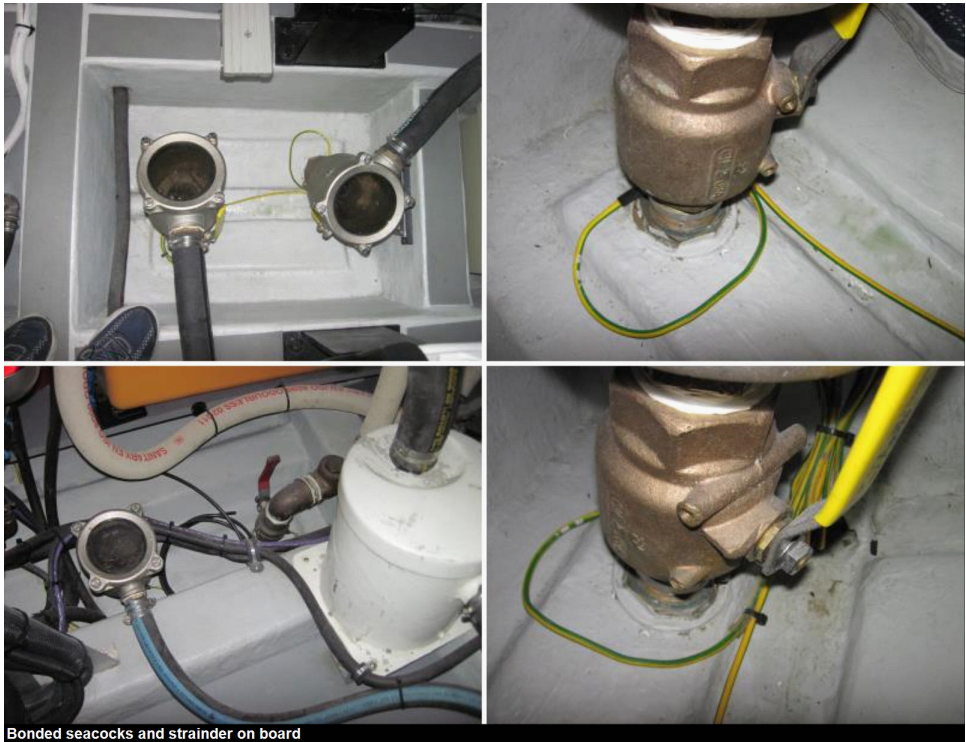
The raw water intake / discharge seacocks below the water line on this vessel were bronze ball valve type seacocks. All seacocks tested on board were properly secured to the hull. No leaks were sighted at any of the seacock locations. All of the seacocks were functional when tested. All seacocks sighted were properly bonded with proper bonding wire except for the anchor wash seacock which was sighted to not be bonded when inspected.

Findings:	Recommendations:
The anchor wash raw water seacock was sighted to not be bonded when inspected.	Have a qualified marine technician install a proper bonding wire on the anchor wash down intake seacock as recommended by ABYC E-2.

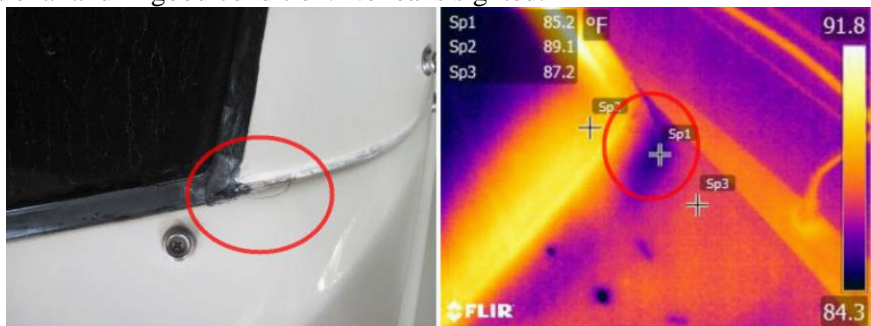
Crack and moisture under windshield

Large two piece tempered glass windshield with FRP frame. Well secured and in good condition. Tempered glass was in good condition. A small crack was sighted in the fiberglass under the port side windshield. Thermal imaging revealed water

trapped below the fiberglass in the crack. Moisture readings were high in the area just below the window (between 15% - 30%).
Yes. Drains were clear, hoses secure and drained overboard.
Grab rails were sighted at the at deck area and around the transom. Made of stainless steel. All grab rails were secured when tested.
24 volt raw water anchor wash down was functional when tested.

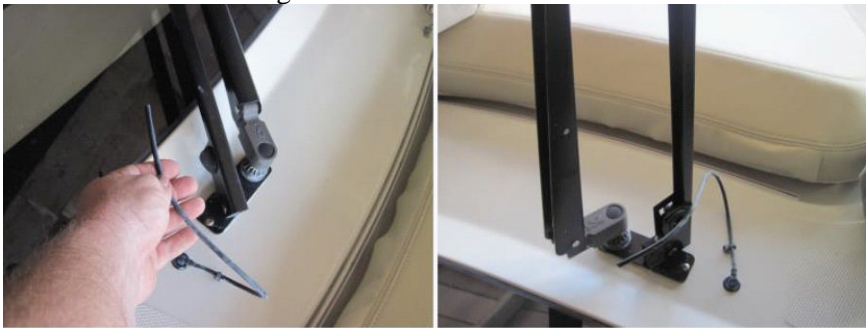
Unattached washer fluid hoses to wipers

Blades appear to be in good condition and were fully functional when tested however the washer tubes were not connected to the blade arms to wash the windshield when inspected.

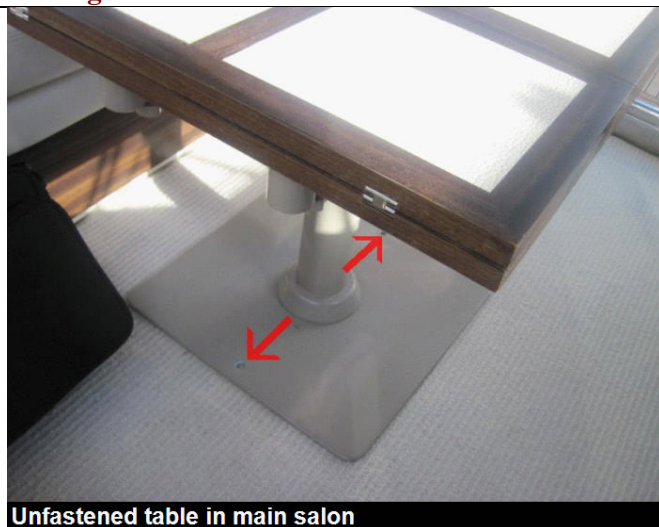
Unfastened table in main salon

One table sighted in the main salon was not mounted to the deck. Fasteners were missing at the time of the survey.

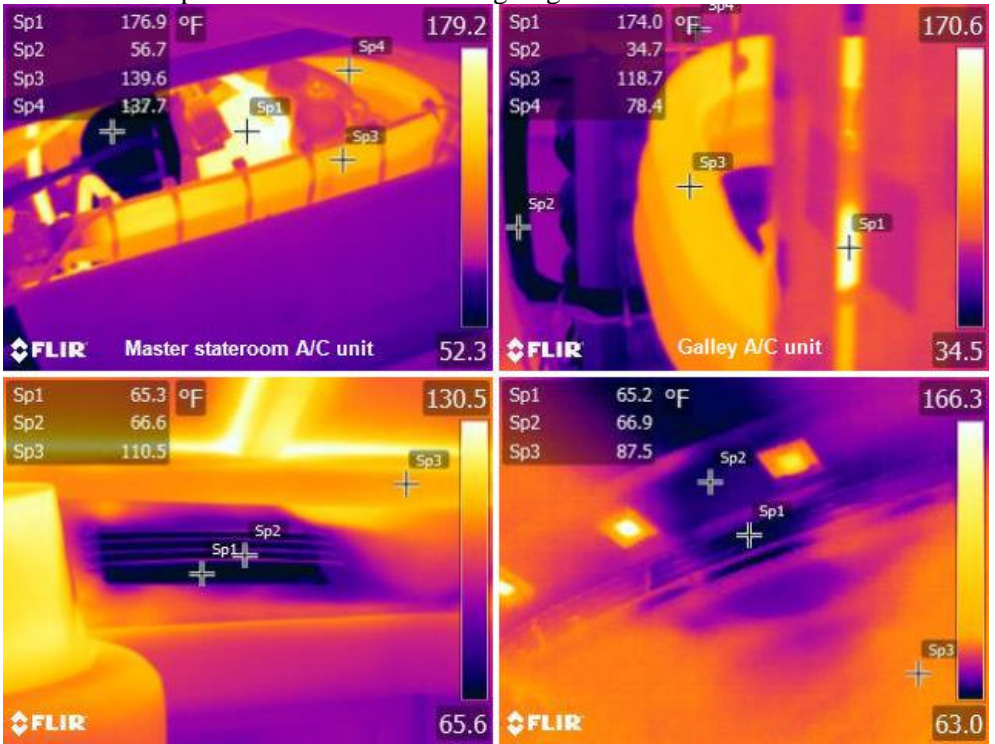
Thermal images of the A/C units, compressor pumps, handler motors, evaporating coils, and hoses on all of the units were normal however the compressor pumps were running slightly hotter than normal. A/C air output was normal on all of the units compared to the surrounding ambient air temperatures when tested.
