REPORT OF MARINE SURVEY

**Pre-purchase Condition and Value
of the vessel**

"Ciao"

2012 40' Azimut 40S

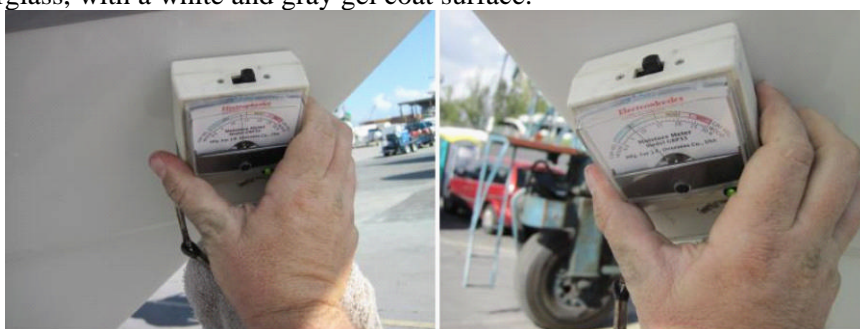
Normal moisture readings on the stem

Solid, no cracks on external inspection. Moisture readings were relatively dry (less than 14%) *Note: Moisture readings of 14% or less are considered dry for fiberglass.*

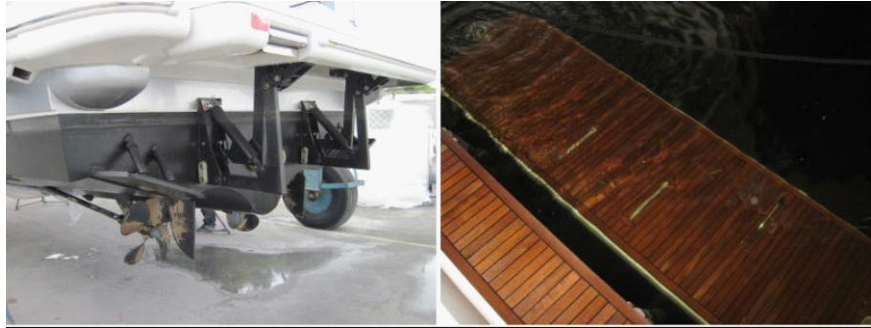
Working swim platform

Open transom with an attached 24 volt / hydraulic swim platform. Functional when tested.

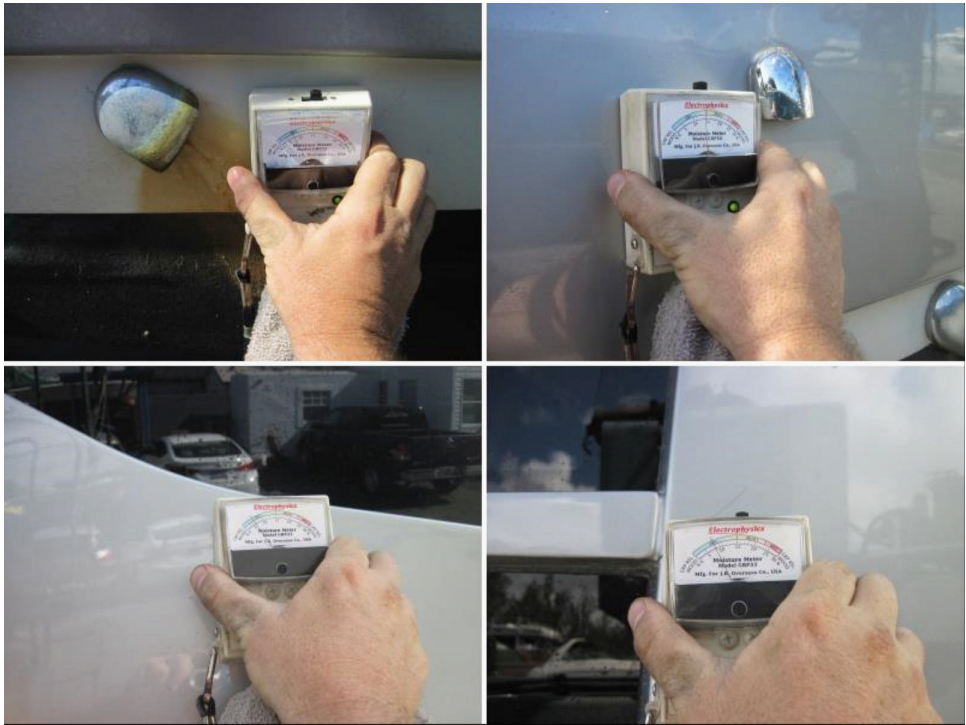
Moisture meter readings on the topsides

All moisture meter readings on side hull near the water line and surrounding thru hull fittings were relatively dry with normal comparative moisture meter readings (less than 14%).

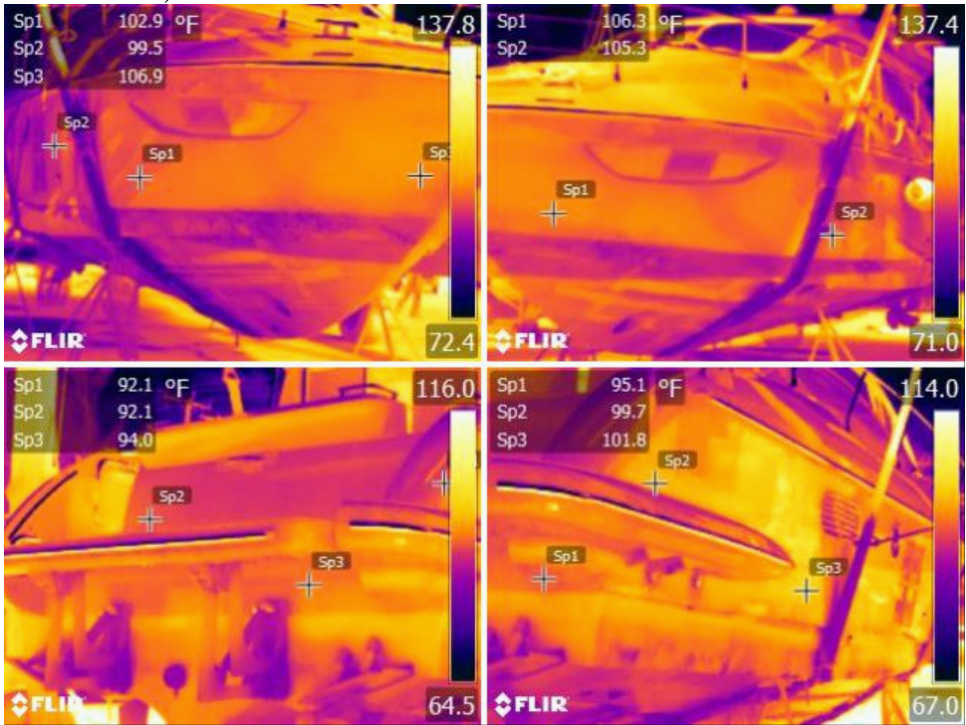
Thermal images of the hull topsides

Thermal images of the hull exterior topsides showed no thermal anomalies that were consistent with delamination, hidden fiberglass damage or blistering.

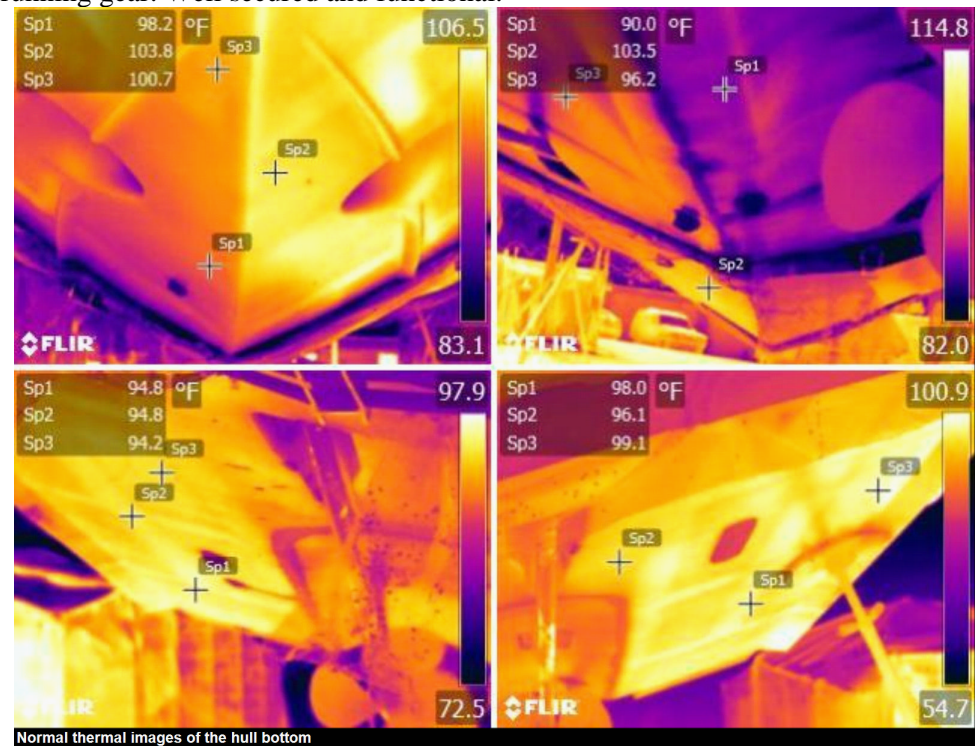
Normal thermal images of the hull bottom

All of the thermal images for the hull bottom were normal. No thermal anomalies were sighted that were consistent with hull damage, previous major fiberglass repair or delamination.

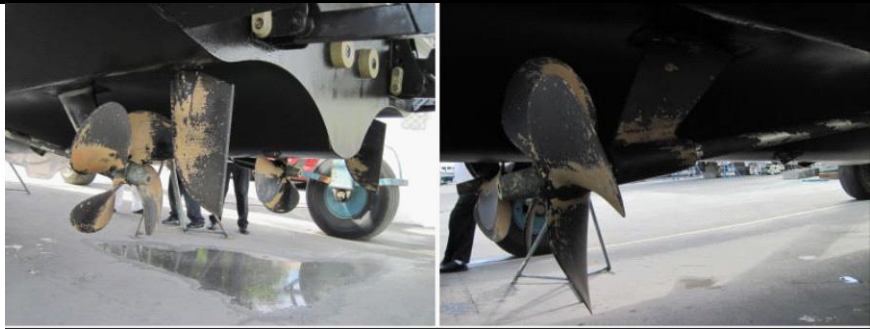
Running gear

The propellers on this vessel were two three bladed bronze propellers. The propellers measured 24.5 inches in diameter and were well balanced and secure to the shafts when tested.

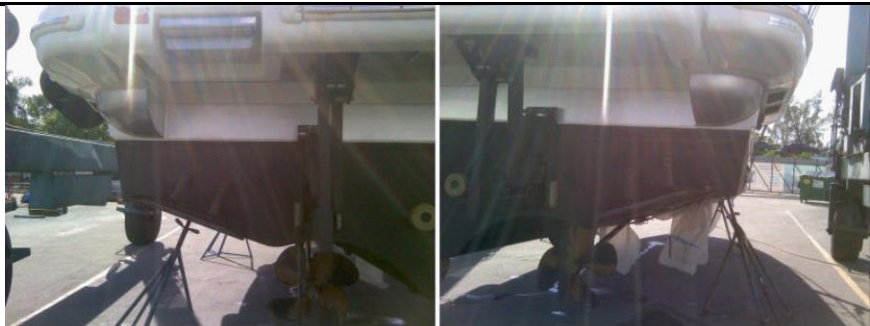
Trim tabs

The trim tabs on this vessel were sighted on the port and starboard sides of the transom below the waterline. The trim tabs were "Bennett" brand double ram, stainless steel 24 volt / hydraulic trim tabs. Both trim tabs were secure and worked properly when tested.

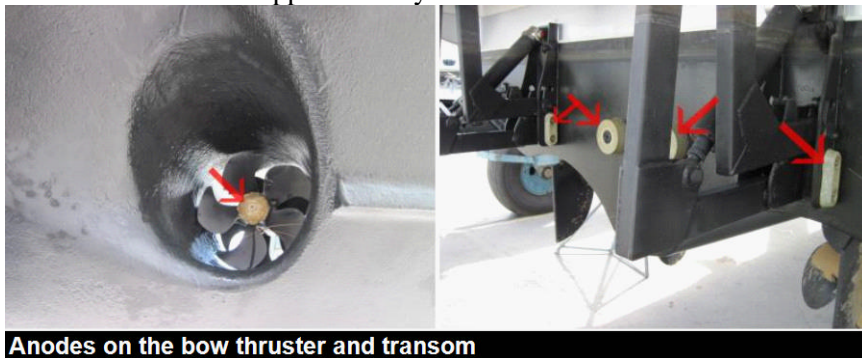
Anodes on the bow thruster and transom

The bow thruster on the starboard side had an anode on the propeller hub. The anode on the bow thruster was secure and in good condition. Less than 10% worn. Anodes were sighted on the swim platform bracket below the water line. Well secured and less than 5% worn.

Monitor all anodes frequently and replace when they are more than 50% worn. Anodes are normal replacement items designed to protect the running gear from galvanic corrosion. It is recommended to keep spares aboard the vessel.

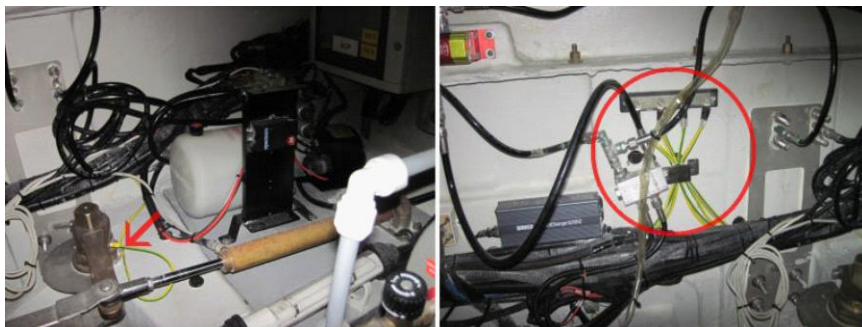
Bonding wires inside the lazarette

Bonding wires for all of the under water running gear was sighted on this vessel. Bonding wires were proper 8 AWG green and yellow striped insulated stranded copper wire as recommended by ABYC.

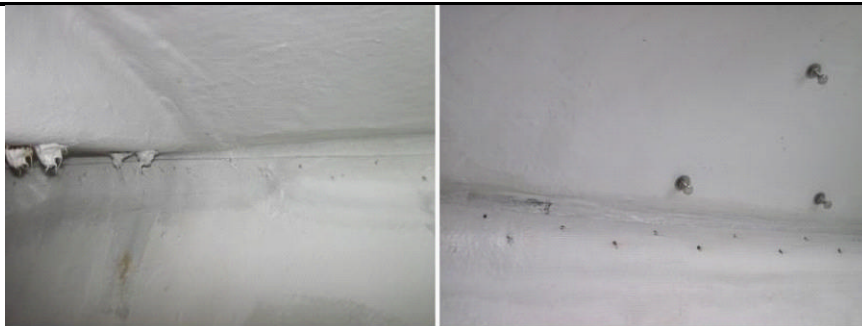
Hull to deck joint

Overlap (Shoe box type). Elastomeric bonding compound was sighted in the hull to deck joint and reinforced with stainless steel fasteners. No leaks were sighted in any part of the hull to deck joint area.

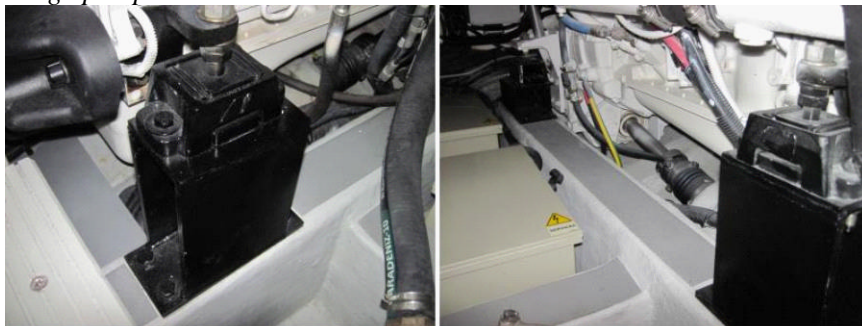
Engine room stringers & transverse frames

Hull stiffness provided by FRP (fiber reinforced plastic) cored longitudinal stringers that ran the length of the vessel. Complete inspection was not possible due to limited access. Stringers and transverse frames were sighted in the engine compartment and under the cabin sole and were well glassed in to the hull where

sighted. Stringers were sounded with a phenolic hammer where accessible and appeared very sound. No soft spots, separations, cracks or splitting was sighted. Limber holes appeared to be adequately sealed where sighted. Stringers were checked with a moisture meter where accessible and all readings were relatively dry (less than 14%). Thermal images were taken along the stringers where they could be accessed. No thermal anomalies were sighted.

Findings:	Recommendations:
Some of the grip tape on the tops of the stringers and transverse frames were peeling off in the engine compartment when inspected.	If desired, have a qualified marine technician repair or replace the peeling grip tape in the engine compartment.

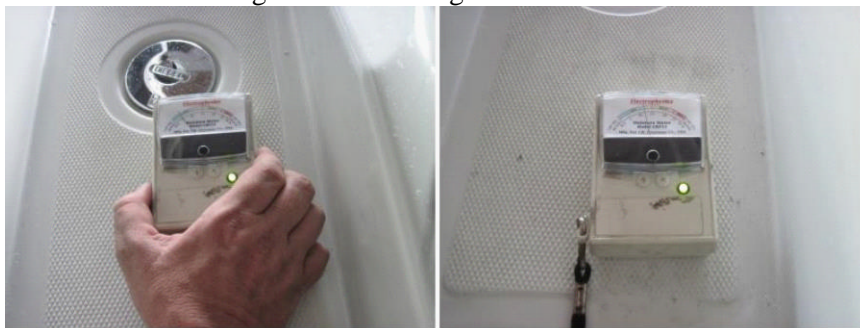
Moisture readings on the decks

Moisture meter readings were relatively dry (less than 14%). No delamination or soft spots were discovered.

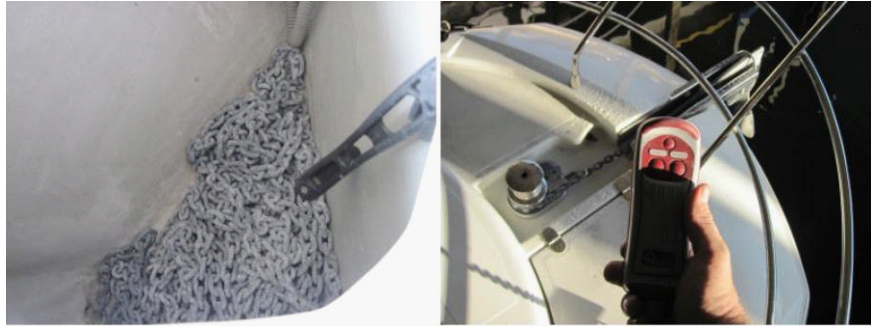
Anchor locker and windlass

The windlass was a 24 volt "Quick" brand windlass. The windlass was made from stainless steel and was well secured to the deck when tested. The windlass was functional in both directions when powered up and tested. Worked at the wired in remote and at the helm station when tested.

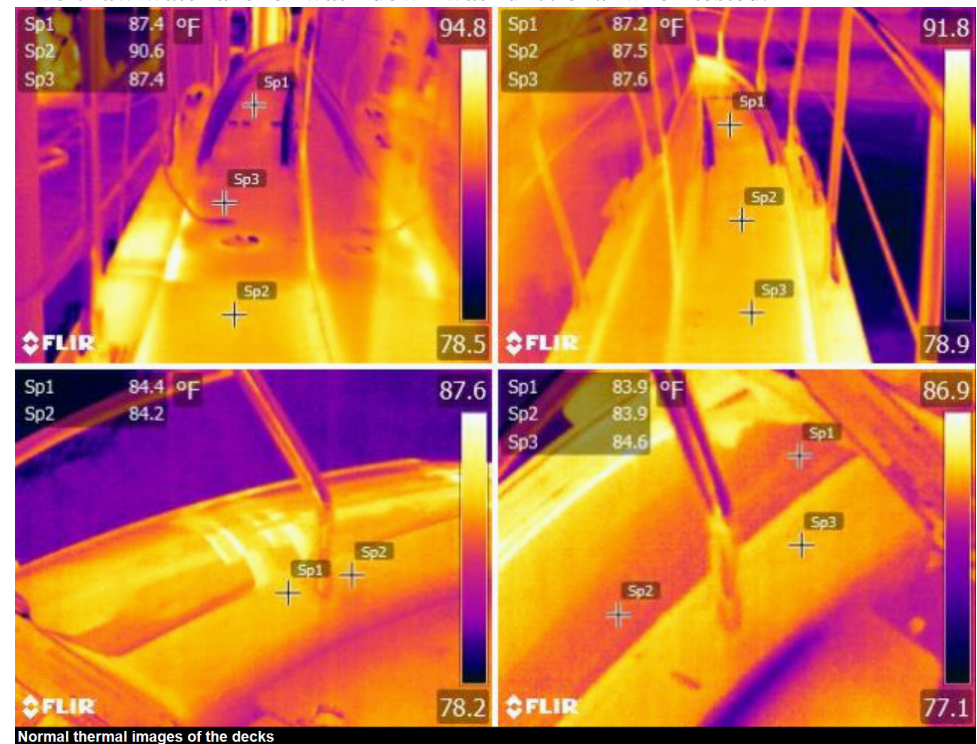
Thermal images were taken of the decks. No anomalies were sighted on the decks that were consistent with delamination or core damage.

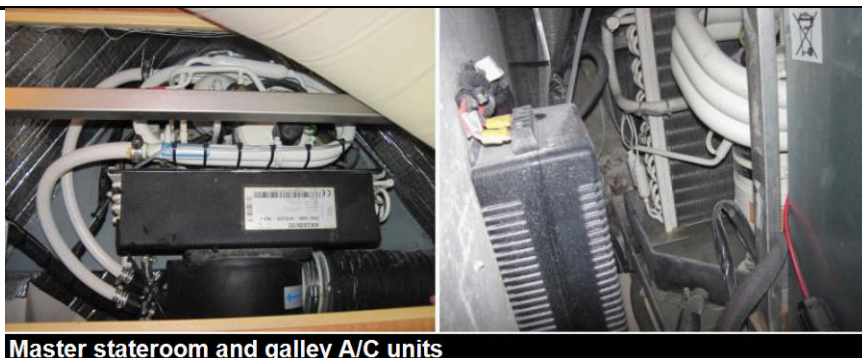
Master stateroom and galley A/C units

A total of two 230 volt reverse cycle air conditioner units were sighted on board this vessel (one under the master berthing in a locker space and one under the galley cabinet aft of the refrigerator). The following are the make, model, and BTU output of each unit sighted:

Each unit had a designated digital "Webasto" digital control unit. Both units were functional when powered up. Single raw water intake was sighted in the aft lazarette for these units. Raw water was supplied by a 220 volt A/C raw water cooling / pressure pump sighted under the generator. The pump powered up when tested. Both A/C units powered up when tested. Both compressors were running slightly hotter than normal when the units were tested (between 168 - 187 degrees fahrenheit on the surface temperature). No leaks or damage were sighted in any of the units or raw water cooling system where they could be sighted.

The air conditioning compressor pump surfaces on both A/C units were running warmer than normal.

Have a qualified marine technician further inspect these air conditioning units to determine the exact cause for the compressors to be running warmer than normal. Repair, replace or renew as necessary. *Note: Typically warmer air and warmer compressor temperatures are an indication that the units are low on Freon. A/C vent output is typically between 45 - 55 degrees fahrenheit*

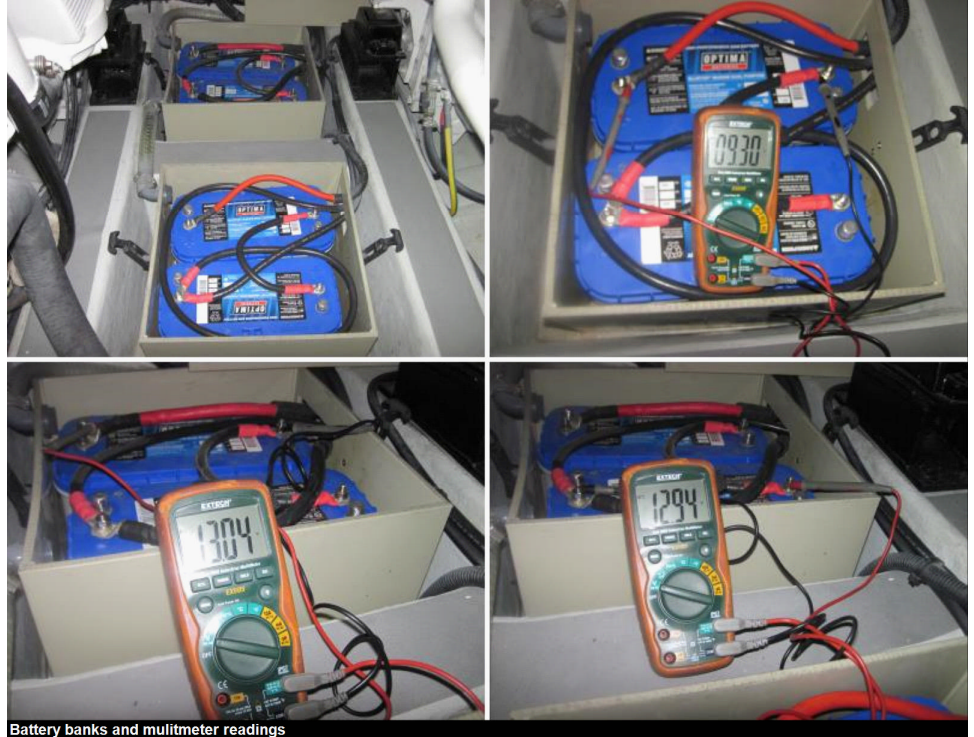
Battery banks and multimeter readings

The primary batteries on board this vessel were six 12 volt "Optima" brand, AGM (absorbed glass mat) "Blue Top" series batteries (model number SC31DM). The batteries were deep cycle marine batteries and were rated at 900 CCA (cold cranking amps). The batteries were charged between 9.80 - 12.85 volts when tested with a multimeter. The batteries were wired in series circuit by two then wired in a parallel circuit from each battery bank. The three series wired battery banks were designated for port engine start, starboard engine start, and house batteries. The batteries were secure to the vessel and in plastic covered battery boxes sighted in the engine room. The batteries were wired with proper gauged battery cable. The generator had its own separate starting battery sighted in a battery box aft of the generator in the lazarette. The middle battery bank between the two engines was low in voltage when tested (both batteries in series 9.80 - 11.00 volts). The battery charger and engine alternators did not charge these batteries when tested.

Findings:	Recommendations:
The middle battery bank between the two engines was low in voltage when tested (both batteries in series 9.80 - 11.00 volts). The battery charger and engine alternators did not charge these batteries when tested.	Have a qualified marine technician further inspect the middle batteries to determine their existing life and cause for them to not be charging. Repair, replace or renew as necessary.

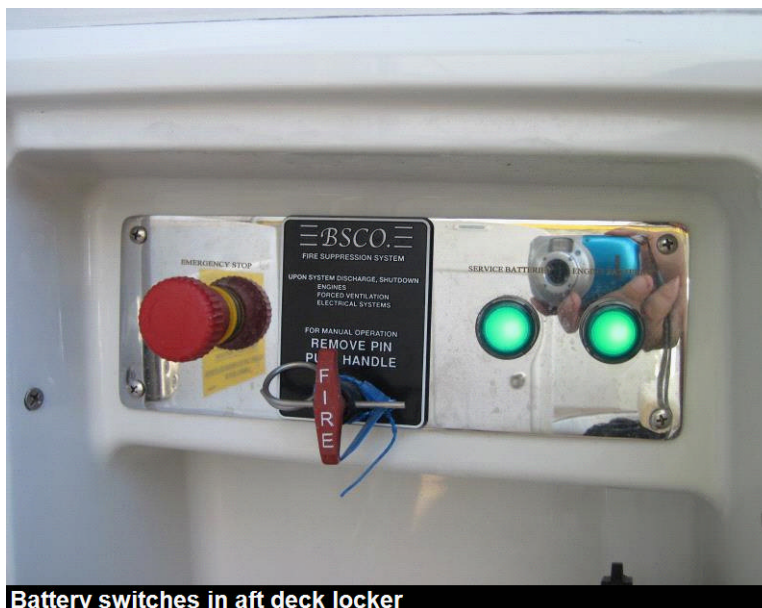
Battery switches in aft deck locker

Push button battery switches were sighted above the battery banks in an aft deck locker. Both switches were functional when tested.

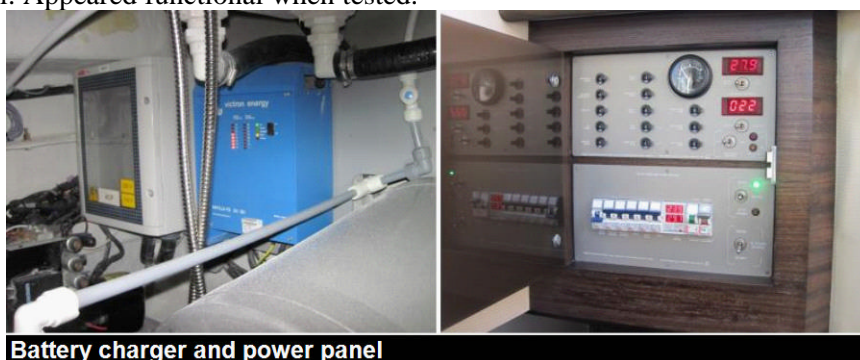
Battery charger and power panel

The vessel's batteries could be charged via the onboard 220 volt "Victron Energy" brand "SKYLLA-TG" series 50 amp marine battery charger or via the vessel's engine alternators. The 220 volt battery charger powered up when tested and charged the batteries. The vessel's alternators charged all of the batteries during the sea trial (except for the middle starting battery bank already mentioned).

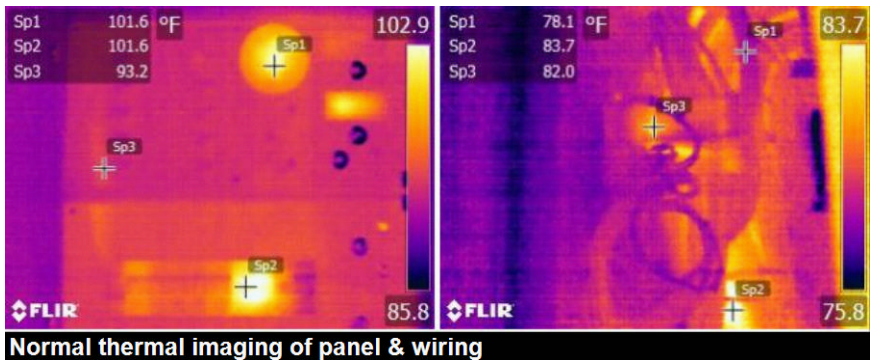
No thermal anomalies were sighted when checking the DC and AC wiring that were consistent with overheating wiring, short circuits or arcing in the wiring where it could be sighted. All branch breakers remained on during the survey without tripping off or failing to remain powered. *Note: For 12 volt systems, a fully charged battery reads 12.7 volts, 75% charged battery reads 12.4 volts, 50% charged battery reads 12.2 volts, 25% charged battery reads 12.0 volts, and a discharged battery reads 11.9 volts or less. Check battery condition and charge frequently. Note: For 24 volt systems, a fully charged battery reads 25.4 volts, 75% charged battery reads 24.8 volts, 50% charged battery reads 24.4 volts, 25% charged battery reads 24.0 volts, and a discharged battery reads 22 volts or less. Check battery condition and charge frequently.*

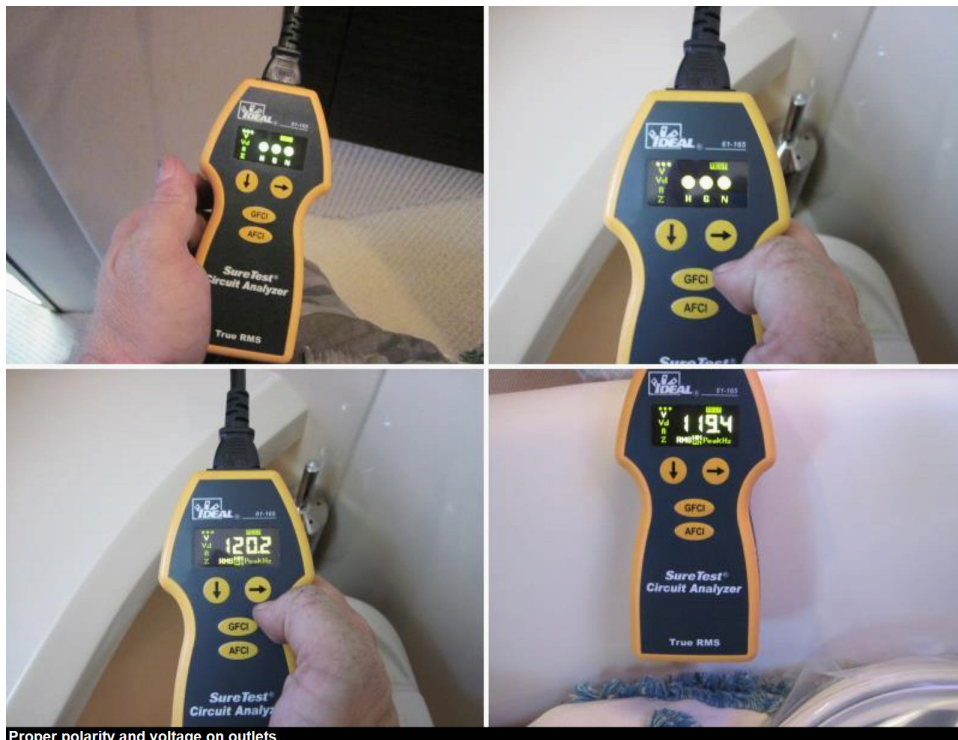
Proper polarity and voltage on outlets

No reverse polarity AC systems were sighted on board this vessel when testing the 110 volt electrical outlets.

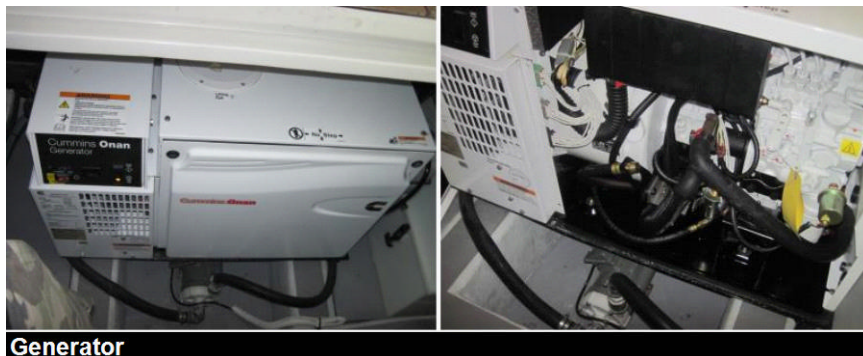
A "Cummins" brand "9MDKBL-5174F" model, three cylinder, four stroke diesel engine generator was sighted in the transom. The generator had a continuous output rating of 9.0 kilowatts. The generator ran properly when tested and was properly secured in place. The generator did not surge when running and had a continuous voltage of 122.7 volts - 124.8 volts when tested (tested at the 110 volt outlets).

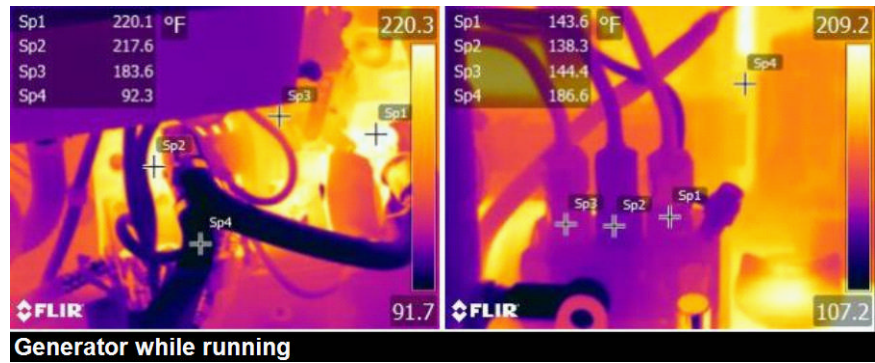
Thermal images taken of the generator were normal while it was running. No unusual thermal anomalies were sighted.

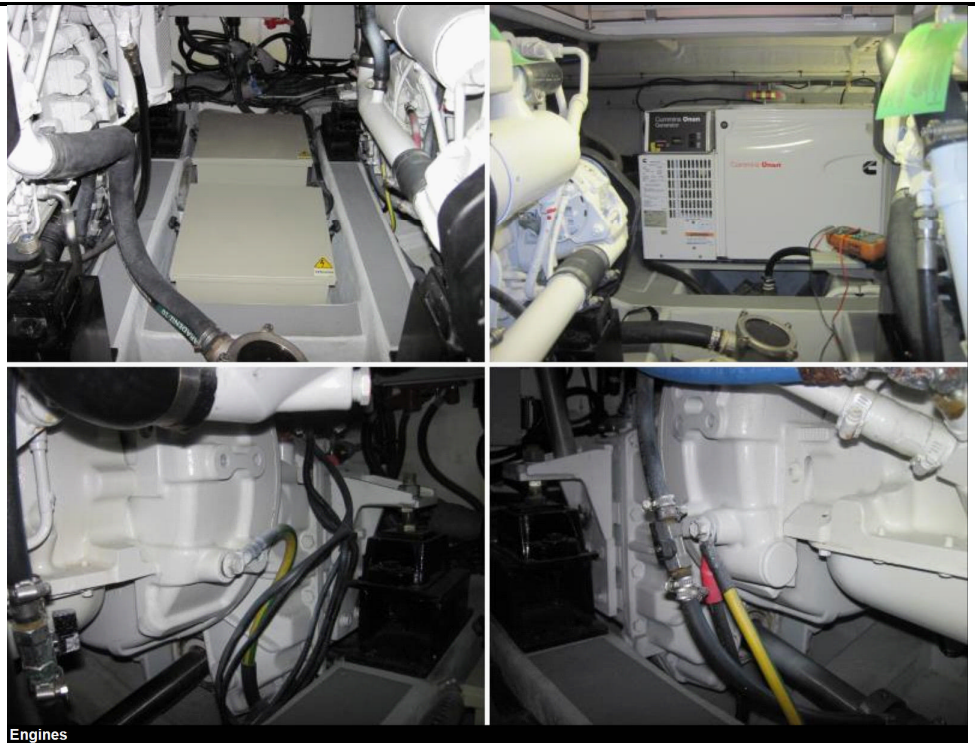
The engines that powered this vessel were two "Cummins" brand "QSB5.9-480 HO" model, in-line six cylinder, four stroke, 5.9 liter, 480 horsepower, turbocharged diesel engines. Both engines powered up and ran properly when tested. No leaks or overheating was sighted. Both engines were labeled to have been manufactured in March, 2011.

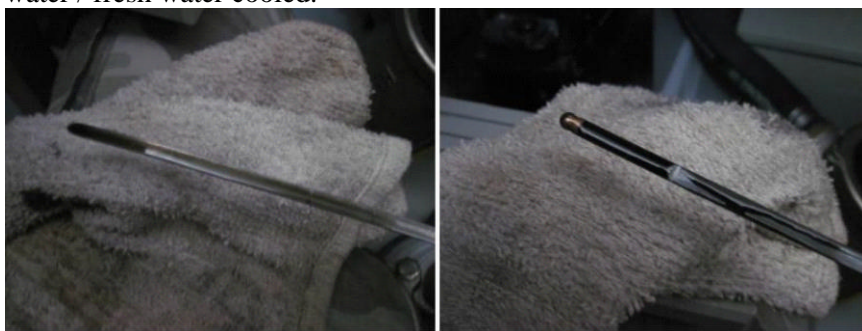
Oil on both dipsticks

Relatively clean and full on both dipsticks. No evidence of water or cuttings in the engine's oil as sighted on the dipsticks.

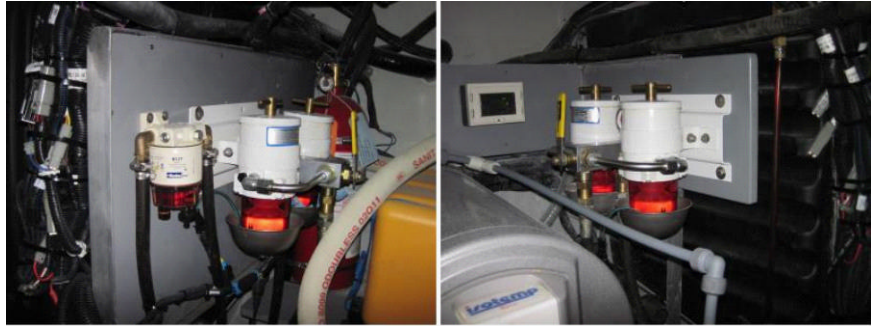
Fuel / water separator filters

"Racor" brand fuel / water separator filters (two filters for each engine). Diesel fuel appeared clean in the sight glasses on each filter.

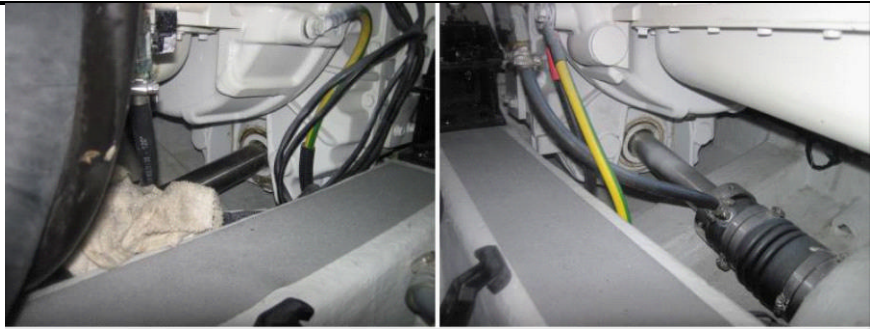
Vee drive transmissions, shafts, and seals

The two transmissions (also known on vessels as reduction gear) attached to the aft section of the engines were "ZF Marine" brand "ZF 63 IV - 2.0" model transmissions. Both transmissions appeared to be in good condition when inspected. Both transmissions were vee drive transmissions.

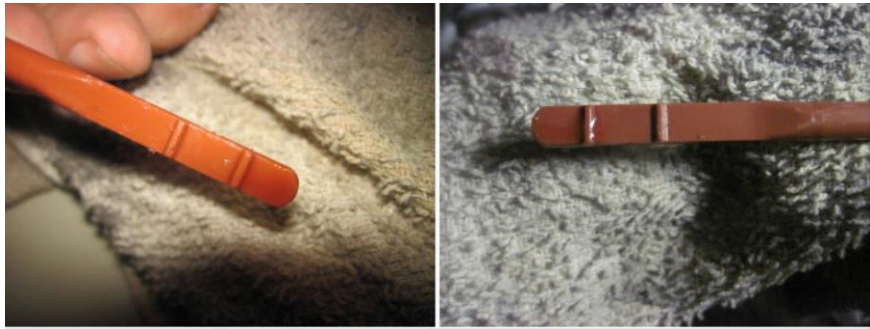
Port and starboard lube on dipsticks

Gear oil was full and relatively clean on both transmissions as sighted on both dipsticks. No foreign debris or cuttings sighted in the fluid as seen on the dipsticks.

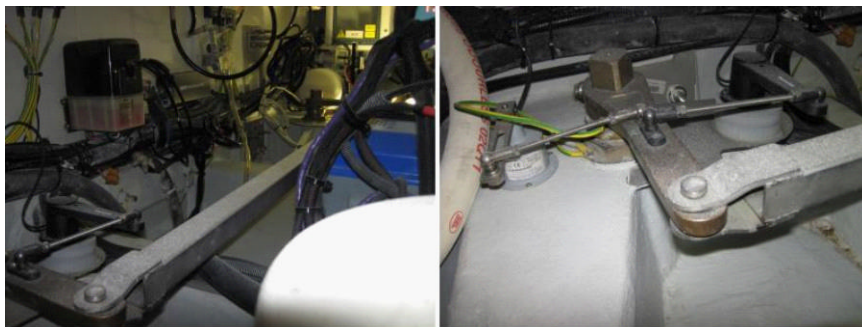
Steering assembly

The steering system on board this vessel was a manual with power assist hydraulic steering system with a single hydraulic ram arm (at the rudders in the lazarette). The rudder arms connected by a stainless steel tie bar that connected the two rudders together. The steering system worked properly when tested and turned both ways equally. No leaks were sighted in the hydraulic lines or ram seals when tested.

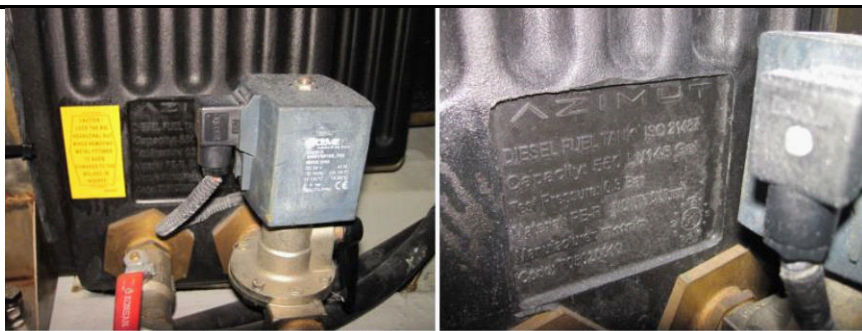
Two fuel tanks were sighted below the aft deck on the outboard sides of the engines in the engine compartment. The tanks appeared to be in good condition with no leaks sighted. The tanks were mounted on a flat surface and appeared well secured. No leaks were sighted on the tanks when inspected. The tanks were "Azimut" brand tanks.

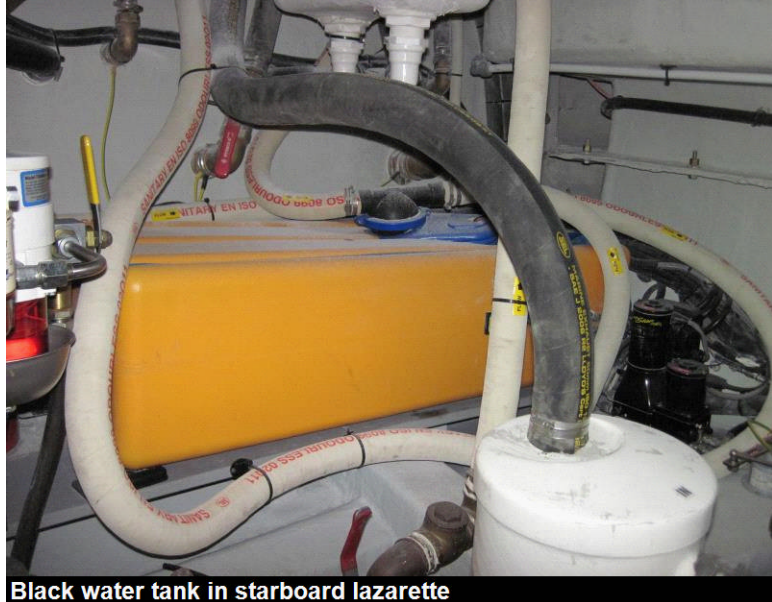
Black water tank in starboard lazarette

One plastic tank sighted in the starboard aft lazarette. In good condition. Pump out chrome deck fitting sighted on the starboard aft gunnel. In good condition. Rated to hold approximately 35 gallons.

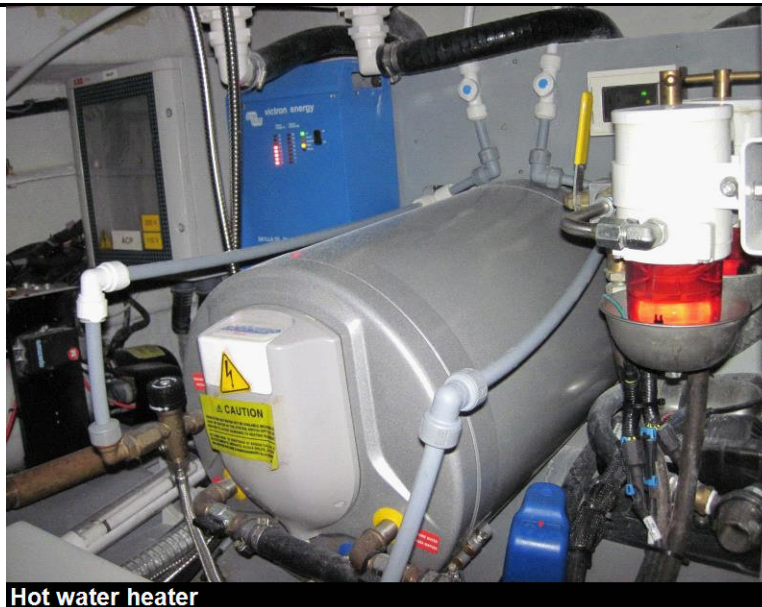
How powered: 220 volts and with heat exchanger coil.
Pressure relief valve(s): Yes.
Drain fixture(s)/plug(s): Yes.
Supply lines: PVC grey water hoses.
Heat exchanger hoses: Heat exchanger hoses appeared to be in good condition where sighted. No cracks or leaks sighted.
Tank(s) secured: Yes.
Inspection/cleaning access: Yes.
Condition summary: Good condition.

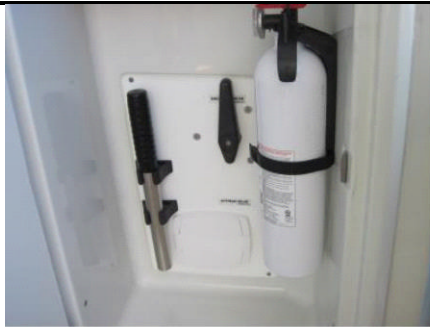
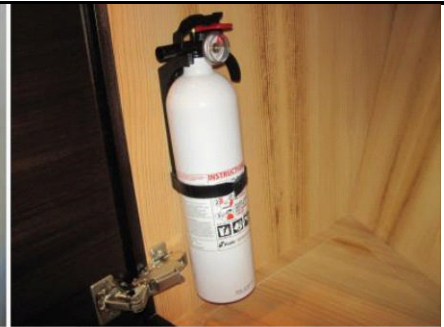
Portable fire extinguishers on board

Three "Kiddle" brand USCG approved fire extinguishers were sighted on this

Findings:	Recommendations:
No current annual inspection tags were sighted on the portable or fixed fire extinguishers.	ABYC A-4 and NFPA 302 recommends that fire protection systems be inspected and reweighed at one year intervals and tagged accordingly. Recommend compliance. <i>NOTE: USCG standards (46 CFR 25) for vessels 40 to 65 feet require at least three BI fire extinguishers or one BII and BI (one fixed system equals one BI or two BII extinguishers). ABYC A-4.6.3 and NFPA 302 Chapter 12 recommends at least four BI fire extinguishers: One outside the engine compartment, one at steering position, and one near the galley and crew quarters or cockpit. Recommend compliance with ABYC and NFPA recommendations for this size vessel. Fire extinguishers should be permanently mounted and readily available using the mounting system for the brand and / or type chosen.</i>

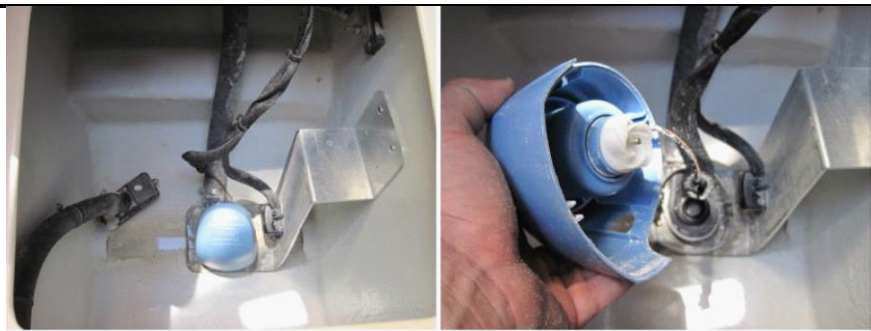
Bilge pump and working impeller

Two bilge pumps were sighted on board this vessel. One bilge pump was sighted in the aft transom bilge and the other was sighted under the forward cabin sole. Both bilge pumps were 24 volt "Whale" brand 1,400 GPH bilge pumps with remote wired in float switches. The bilge pumps were wired into a fused protected circuits as recommended by ABYC. The bilge pumps both powered up when tested. Whale type manual operated bilge pump sighted in the forward and aft bilge spaces. Both appeared functional when tested.

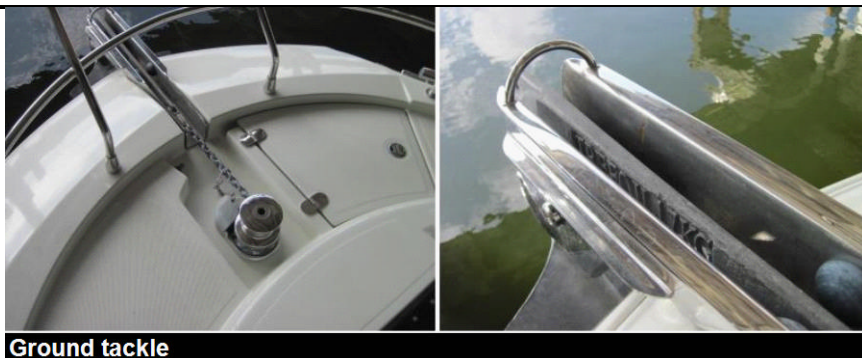
Ground tackle

The primary anchor was a galvanized steel "Trefoil" brand plow type anchor. The anchor was rated to weight 17 kilograms (37 pounds) and was properly rated for this size vessel. The anchor was attached to approximately 200 of 5/16 inch diameter galvanized steel chain. The entire ground tackle was in good condition when inspected.

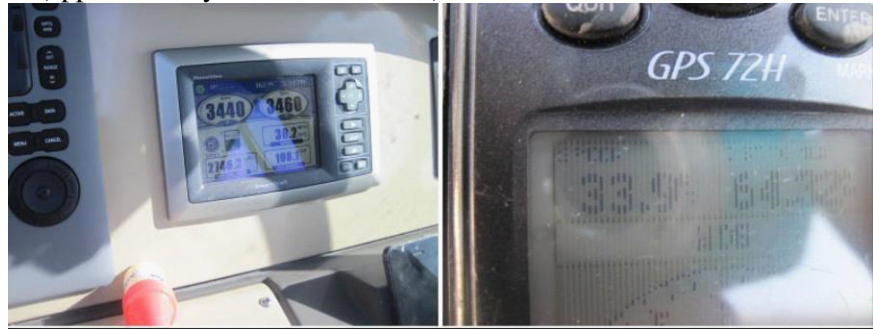
Instrument readings at WOT

The vessel's engines started up properly and both engines had adequate exhaust discharge. All exhaust smoke was normal with no unusual vapors noticed. The vessel ran smoothly and accelerated properly as power was applied to the port and starboard engines. The vessel's wide open throttle (WOT) was at 3,440 RPM on the port engine and 3,460 RPM on the starboard engine. The vessel's top speed was recorded at 33.9 knots at WOT. The vessel was able to back down properly on both engines. The turning radius of the vessel was approximately 50 feet when the rudders were turned at hard over on the port and starboard sides. The vessel's turning radius was approximately equal on both sides. During the time the engines were running at WOT, the following temperature readings were recorded (all readings were recorded in degrees fahrenheit with an infrared thermal imaging camera): Port engine block: 210.8 degrees, starboard engine block: 212.6 degrees, port exhaust manifold: 188.2 degrees, starboard exhaust manifold: 183.2 degrees, port raw water exhaust hose: 102.5 degrees, starboard raw water exhaust hose: 107.6 degrees, port reduction gear (at bearing at coupling connection): 167.2 degrees, starboard reduction gear (at bearing at coupling connection): 172.5 degrees. No significant variation in temperatures were sighted around the cylinder heads or heat exchangers on the engines. Turbochargers on both engines ran properly with no overheating or leaking sighted. All temperature readings were within reasonable normal limits. No leaks were sighted in any of the exhaust components or hull pass through locations during the sea trial. All engine mounts appeared to be secure to the stringers during the backing down maneuvers. The generator ran at normal temperatures with no surging of the generator power as systems were running.

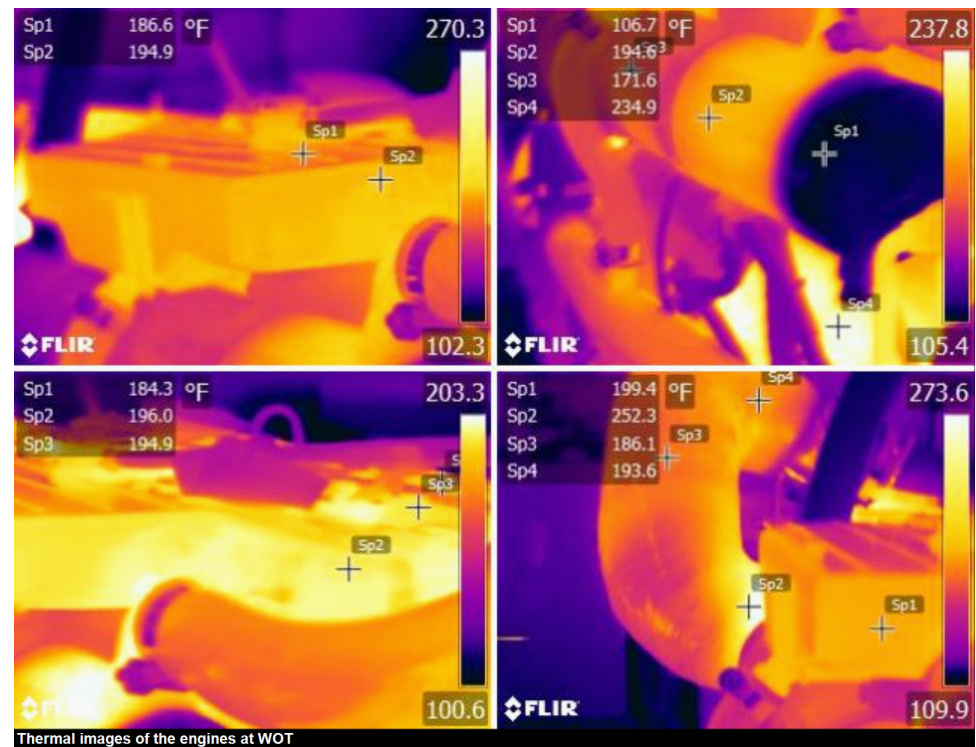
Thermal images appeared normal on the engines. No abnormal thermal anomalies were sighted while the engines were running.
